GEORGE C. TOLAND

November 20, 1992

ANNUAL INSPECTION OF SEDIMENT POND DAM
GOLDSTRIKE MINE
WASHINGTON COUNTY, UTAH
FOR TENNECO MINERALS

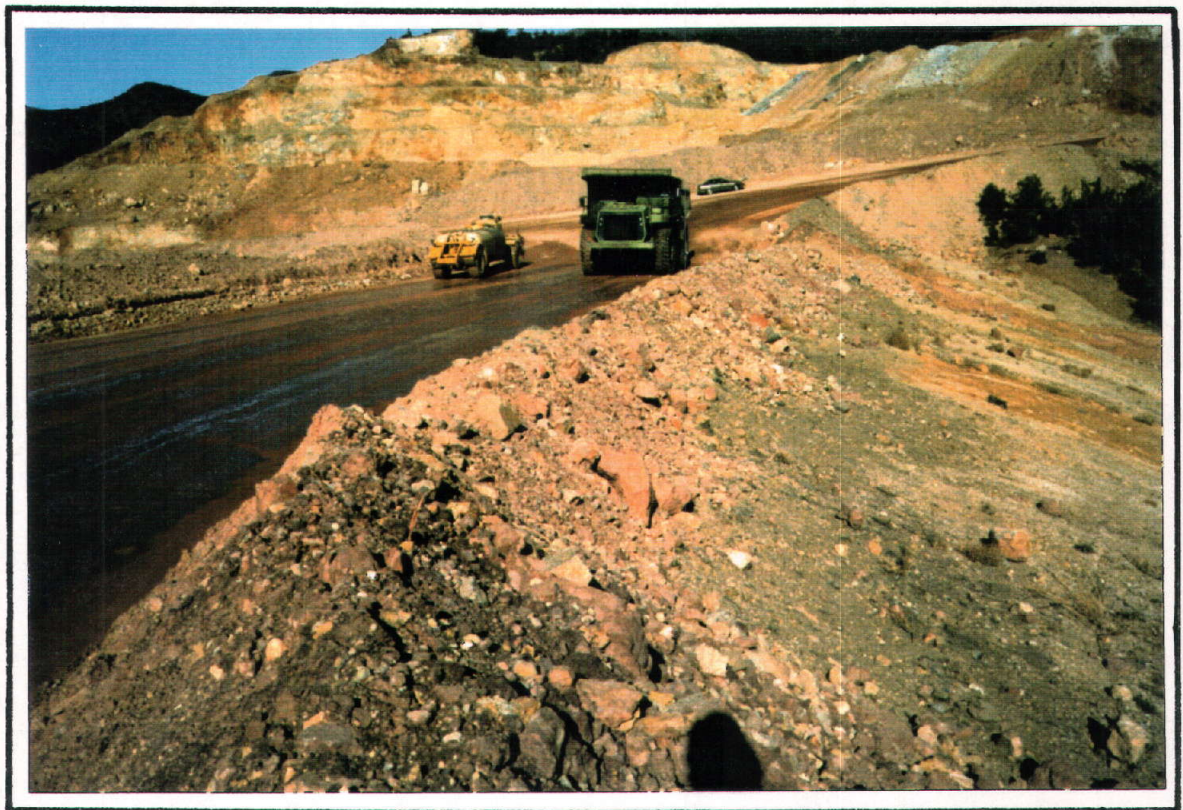
The crest of the dam is now being used as a haul road and the emergency spillway has been replaced by two 24-inch pipes (see Photographs 1 and 2). The spillway will be re-established when the pit in the area of the dam is completed.

PHOTO 1: CREST OF DAM, CURRENTLY USED AS HAUL ROAD.

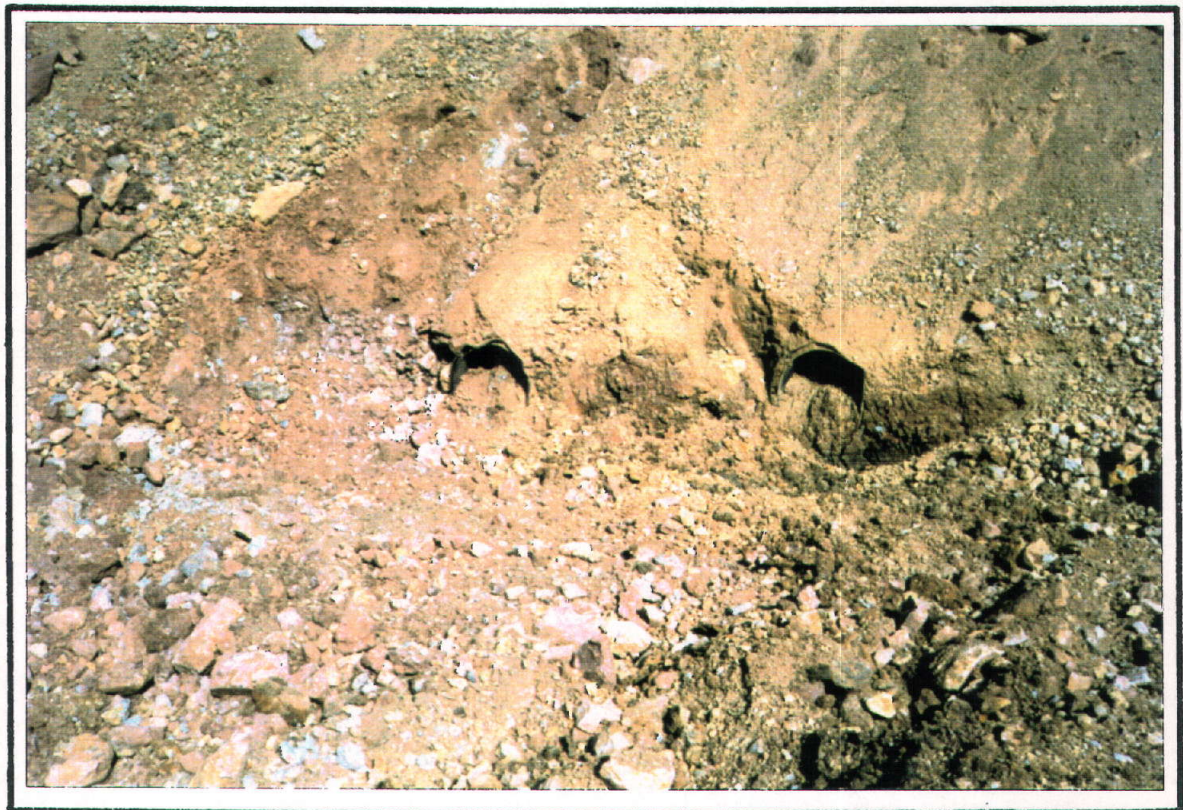
PHOTO 2: SPILLWAY AREA WITH PIPES. WILL BE RE-BUILT AFTER MINING.

Tenneco Minerals personnel should continue to observe the dam and reservoir, and should report any seepage or embankment movement to our office. The spillway should be re-established as soon as the mining in the area is completed.

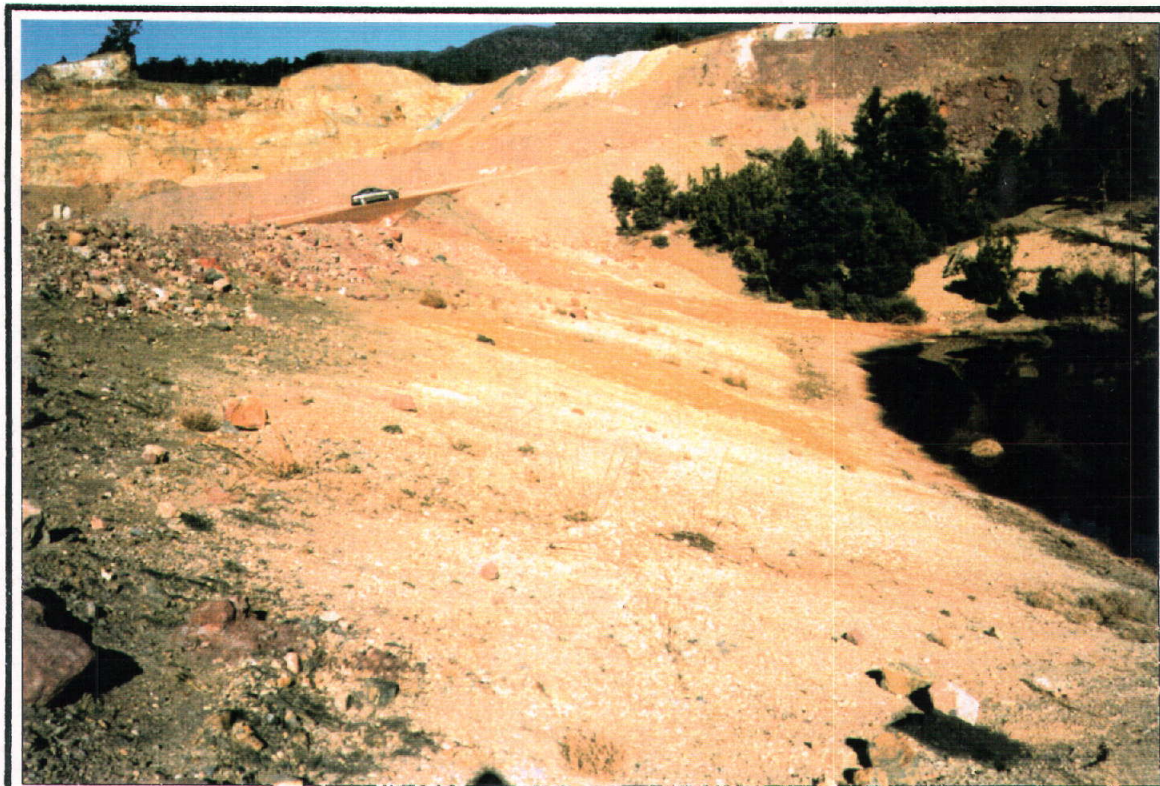
PHOTO 3: UPSTREAM SLOPE OF DAM AND WATER IN POND.

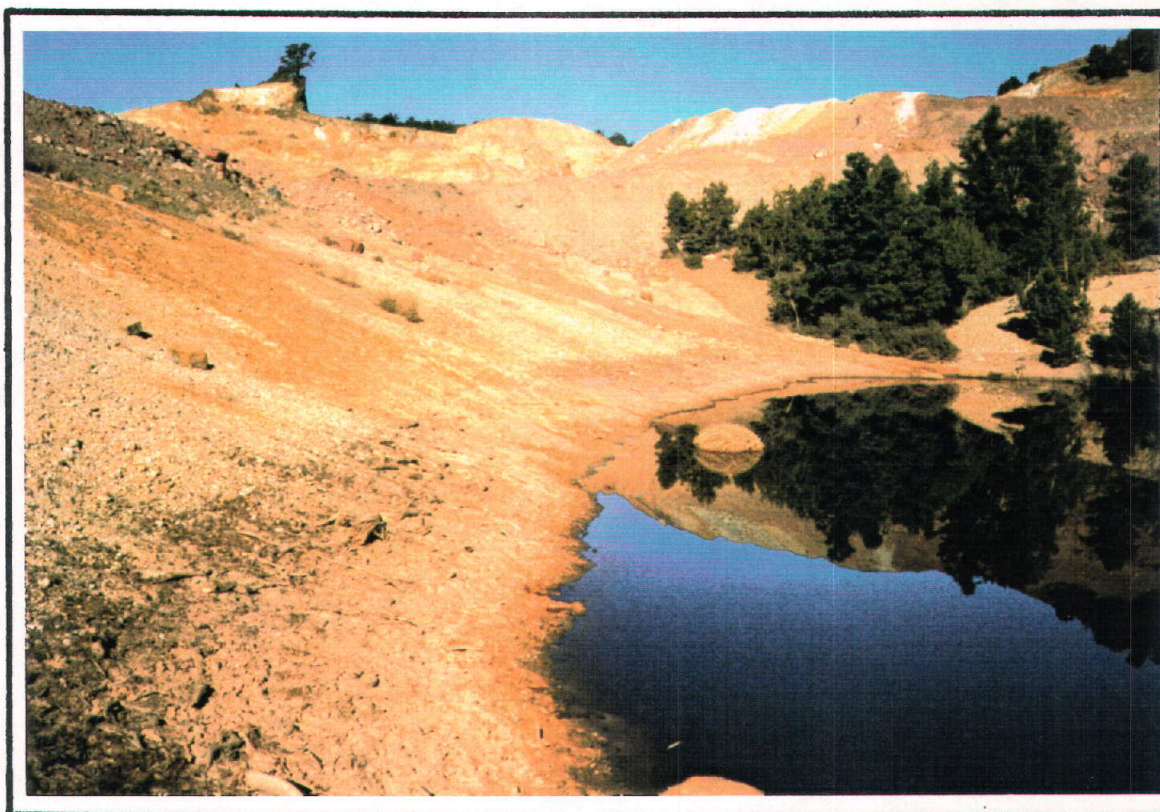
The seepage problem described previously was not present at the time of this inspection. Photograph 4 shows the upstream toe of the dam where flood-carried silt has sealed the voids in the dozer placed fill. Photograph 6 shows the area where seepage was occurring in 1991.

PHOTO 4: WATER IN POND AND SILTED AREA OF FACE.

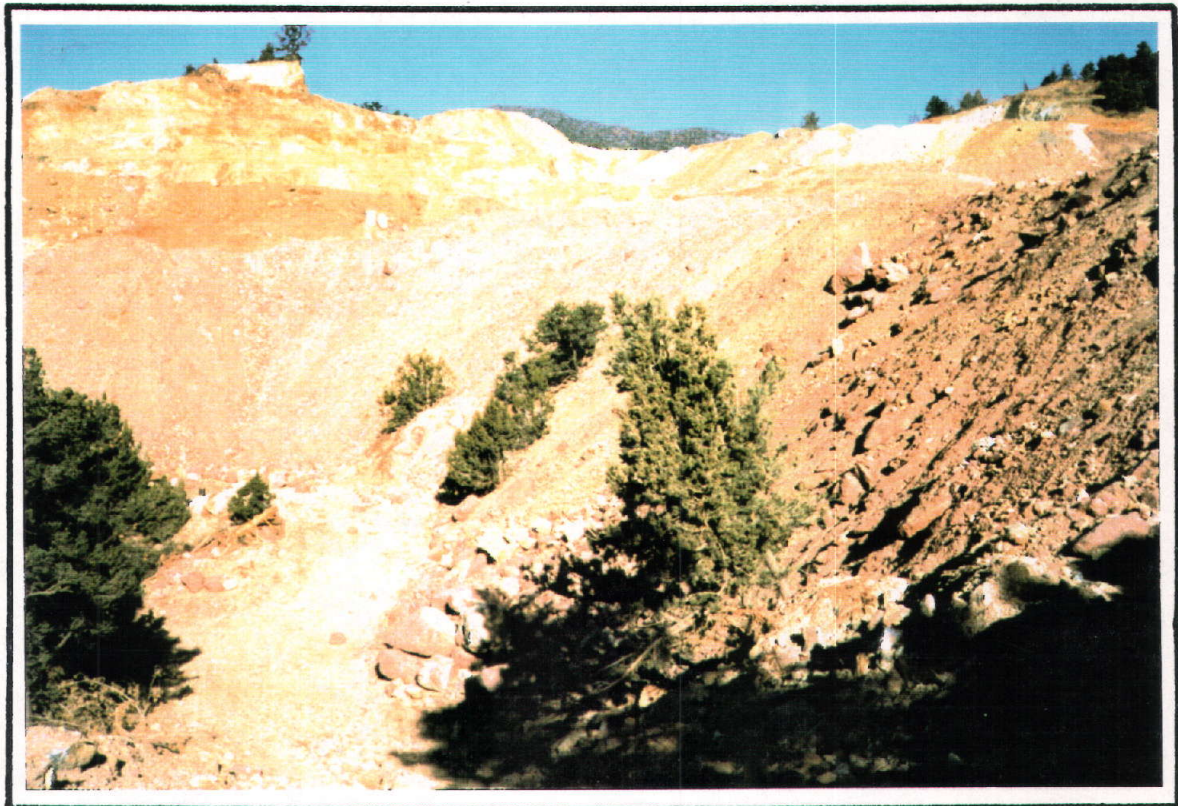
PHOTO 5: DOWNSTREAM SLOPE OF DAM.

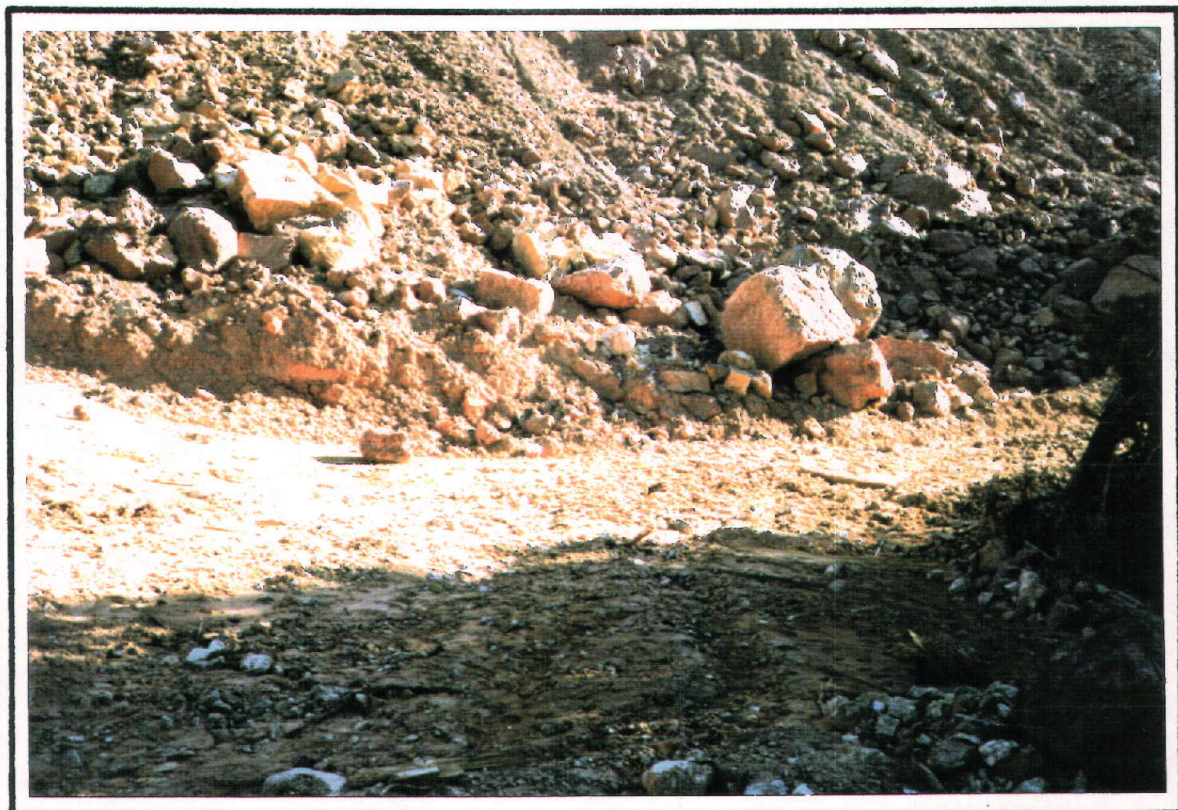
The Sedimentation Pond Dam and reservoir is performing well. There were no indications of stability or seepage problems. The seepage problem observed in 1991 was not a structural concern to

the dam. This seepage has not occurred for more than a year and there is no indication that it will re-occur.

PHOTO 6: DOWNSTREAM TOE OF DAM WHERE SEEPAGE OCCURED IN 1991.
